Flexural Performance of Prestressed Beams with Grouting Material of Various Compactnesses

Xuansheng Cheng^a, Haibo Liu^b, Jiaxuan Su^c, Liang Ma^d, and Guoliang Li^a

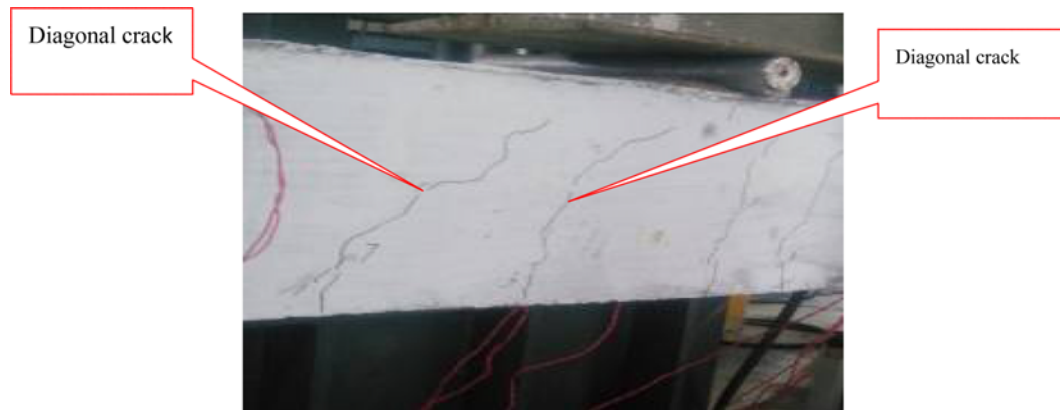
Fig. 4. Diagonal Crack Development

The phenomenon observed for each test beam was similar, and PCB1-3 was taken as an example. Under the action of a large load, when the load increased to 42.5 kN, vertical cracks first appeared in the middle part of the span of the lower edge of the test beam, and the midspan deflection reached 4.15 mm. As

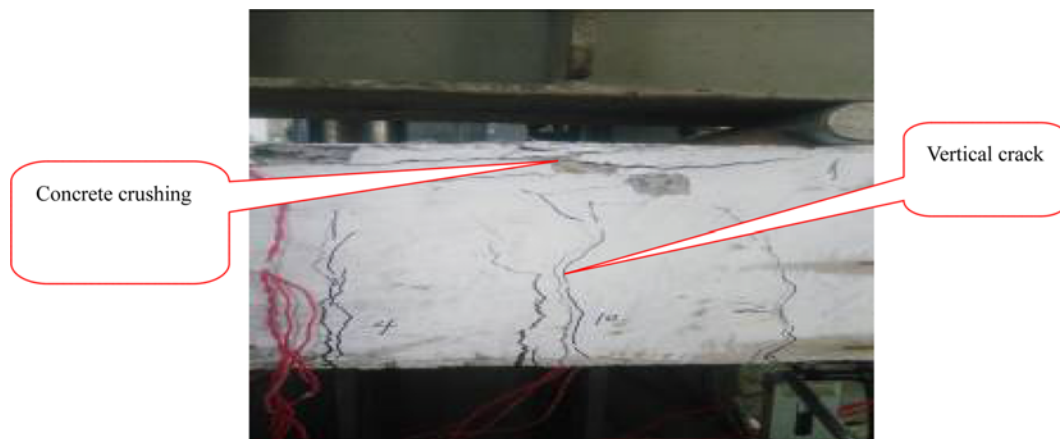
Fig. 5. Vertical Crack Development

the load continued to increase, the cracks gradually extended upward along the cracking direction. In addition, as new cracks appeared successively, the crack spacing decreased, and the vertical cracks appeared just below the loading point, as shown in Fig. 4. When the load increased to 93.2 kN, the concrete near the upper loading point of the pure bending section of the prestressed beam was crushed, and the bearing capacity of the concrete rapidly decreased. At this time, the deflection in the middle of the span reached 24.46 mm, as shown in Fig. 5. Table 4 showed the cracking load, crack deflection, ultimate load and

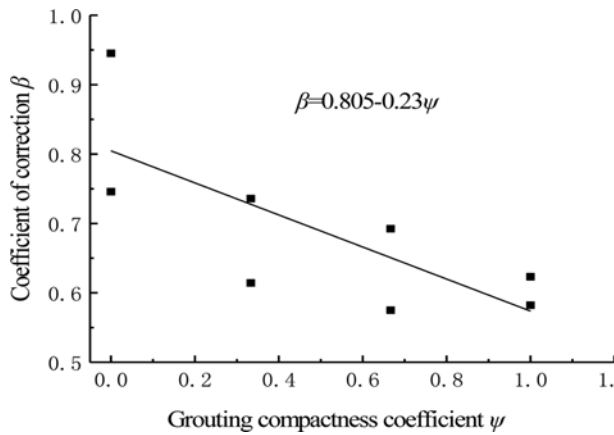
Fig. 8. Linear Regression Results

and the result of the linear regression was shown in Fig. 8.

The coefficient of correction β can be expressed as:

$$\beta = 0.805 - 0.23\psi \quad (1)$$

where ψ is the compactness coefficient.

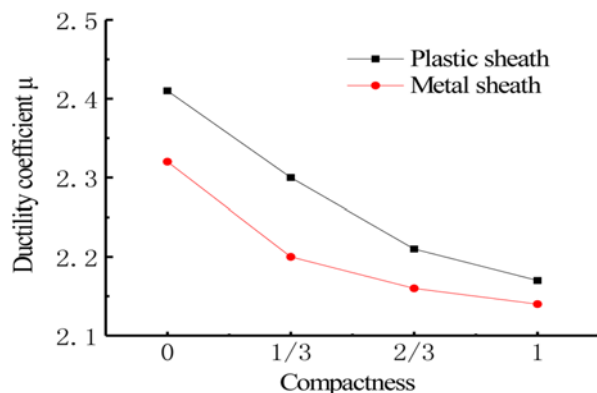
Fig. 10. Comparison of Ductility Coefficients

Figure 10 showed the contrasting curves of the ductility coefficients of the prestressed beams of metal and plastic sheaths with different levels of grouting compactness. The ductility of the prestressed beams with different sheaths material under different levels of grouting compactness was analyzed.

As seen from Fig. 10, the ductility coefficients of the metal and plastic corrugated prestressed concrete beams decreased with an increase in the grouting compactness. Therefore, the ductility of the prestressed concrete construction with insufficient grouting was better than that of the fully grouted prestressed concrete. That is, the unbonded prestressed beams were more ductile than the

bonded prestressed beams. In addition, the ductility coefficient curve of the plastic sheaths was clearly and consistently above the ductility coefficient curve of the metal sheaths, but the curves became more similar with an increase in the grouting compactness. This finding meant that the ductility of the prestressed beams with plastic sheaths was better than that of the prestressed beams with metal sheaths. The difference in the ductility coefficient between the two kinds of sheaths was smaller when the grouting was denser. That is, the sheaths had little effect on the ductility of the beam when the grouting was dense.
